Historic Property Safeway (Demolished)
Inventory Report for 609 4th Ave E, Olympia, WA 98501

Field Recorder: ss **Date Recorded:** 9/9/2005 **Survey Name:** OLYMPIA-MODERN

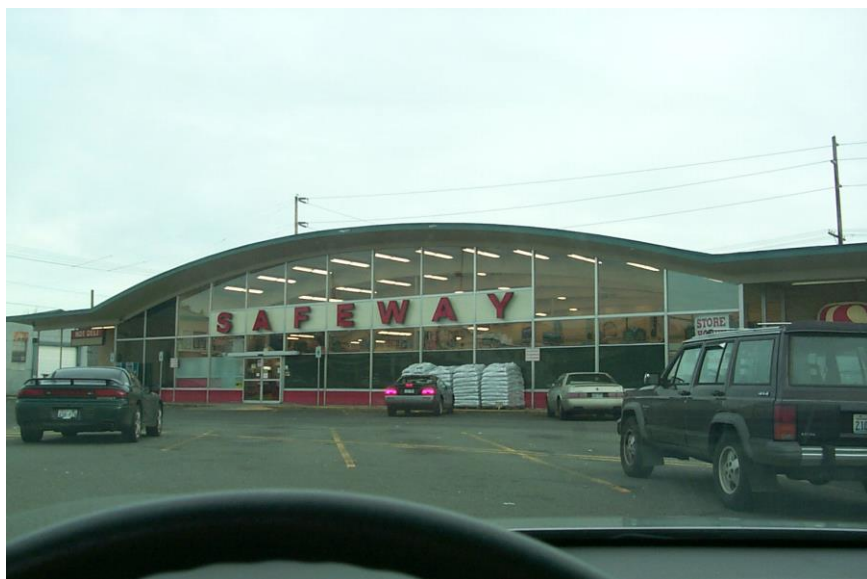
Description of Physical Appearance This a Classic arched glass center design Safeway store. The rectangular building is set on a poured concrete foundation and constructed of concrete block. The glass panel front faces north and the glass panels extend around the sides of the projecting center front section. The building is fronted by the parking lot. The enframed panels are arched on the top section and a "SAFEWAY" letter panel is centered on the front section, otherwise it is glass, with one entry. The bottom panels on the front of the building are solid red fiberglass. The entire building has a barrel vault roofline. The roofline extends over the center, arched, glass area and extends into flat sides flanking the center which creates a recessed area for the side entries into the glass panel center section. The backs of the side elements are faced with sandstone brick, now painted. The side canopies are supported by round metal posts. There appears to be a newer automatic door which is in the east side of the front which replaces some of the original glass panels.

View of North façade
