**Historic Property** Don & Irene Elliot House  
**Inventory Report for** 1603 4th Ave W, Olympia, WA 98501

**Historic Property**    Don & Irene Elliot House  
**Inventory Report for**    1603 4th Ave W, Olympia, WA 98501

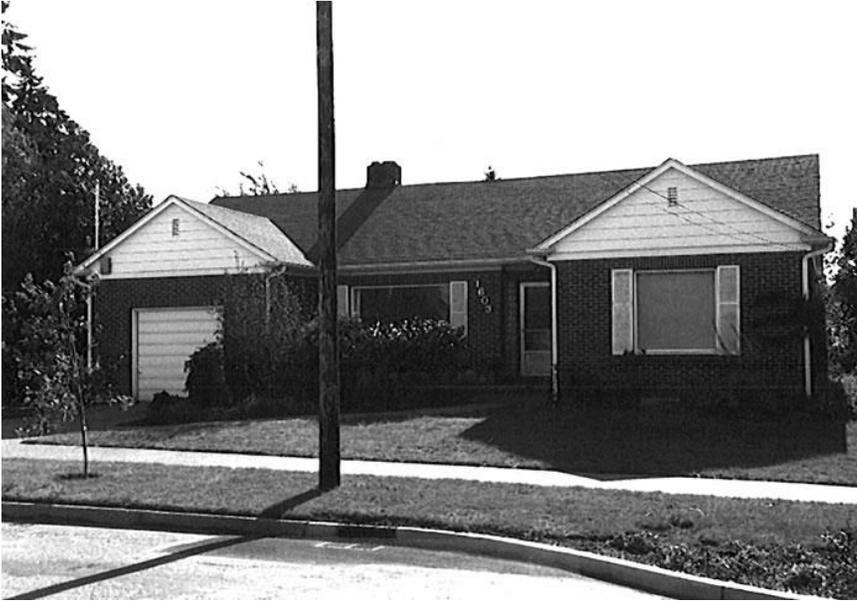
The U-shape plan home is capped with a gable roof covered in green three-tab asphalt shingles. Simple cornice returns, formed by the gutters, are found at the boxed-in eaves. The main façade is dominated by two projecting gable wings and two large picture windows. The living room window measures 5'0" x 8'0", while the window in bedroom 1 is 5'0" x 5'0". Other windows on the home are wood, one-over-

two, double hung sashes in a cottage style arrangement. The rather simple main façade is highlighted by an ornate entry tucked into the corner of a raised concrete porch. Here, a solid maple veneer door is flanked by curving, full-height, glass block sidelights.

View of    Front (north) façade  
taken  
Photography Neg. No. (Roll No./Frame No.):
