Historic Property Ellsworth House
Inventory Report for 203 19th Ave SW, Olympia, WA

Historic Name: Ellsworth House **Field Site No.:** 3478
Common Name: **OAHP No.:**
Property Address: 203 19th Ave SW, Olympia, WA
Comments: OLYMPIA

National Register District/Thematic Nomination Name: SOUTH CAPITOL NEIGHBORHOOD HISTORIC DISTRICT

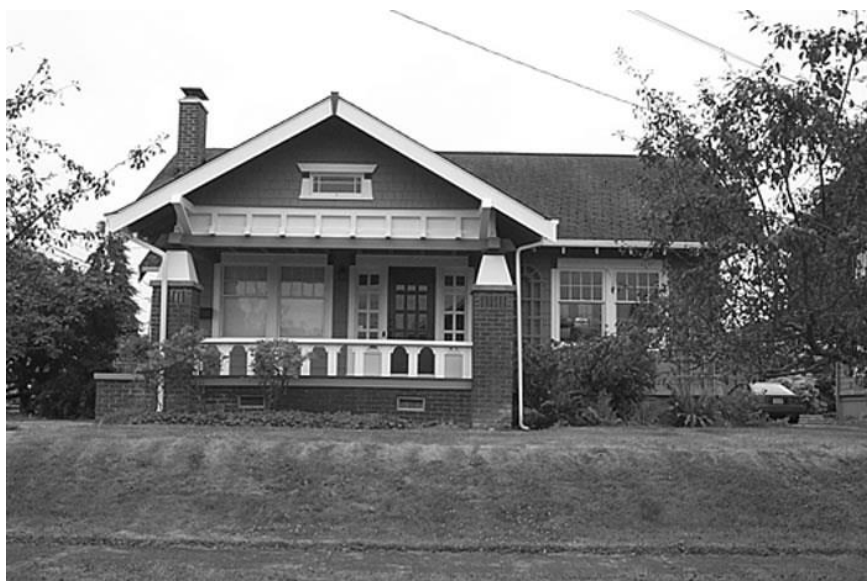
Set on a corner lot, the house is a one and one-half story cross-gable house set on a poured concrete foundation. The roofline has wide, bracketed eaves with a decorative fascia board. The house has wide clapboard cladding with shingling in the gable ends. The front porch projects from the east side of the house with a large gable with similar roofline detailing to the main house. The lower part of the front gable has a decorative bracket band motif across the front of the porch gable. The porch is supported by squat brick pillars. The tops of the pillars are tapered wooden elements. There is a low brick foundation around the base of the porch. Stairs lead from the ground level on the east side of the porch. There are squat brick posts on either side of the stairs. There is a low, wood railing with arched elements on the front and sides of the porch. There is a squat, rectangular window with rectangular muntins and a tapered wide, wood surround in the gable end of the porch. The center front entry has a multi-pane door and is flanked by multi-pane sidelights. The front façade has paired eight-over one windows flanking the main entry. Other windows are paired six-over-one, eight-over-one, or multi-pane or multi-pane casement. There is a one story projecting section on the east side which extends from the rear of the house. It has similar roofline detailing to the main house and a gable window similar to the front porch. There are two doors on this façade, one to an upper area and one to a lower area. A long window with three panes flanks the rear entry door. A large, tapered, brick chimney arises on the east side of the main house.

View of Front Façade
