UNITED STATES DEPARTMENT OF THE INTERIOR
NATIONAL PARK SERVICENATIONAL REGISTER OF HISTORIC PLACES
INVENTORY -- NOMINATION FORM

Washington State Capitol Historic District

Capitol Campus

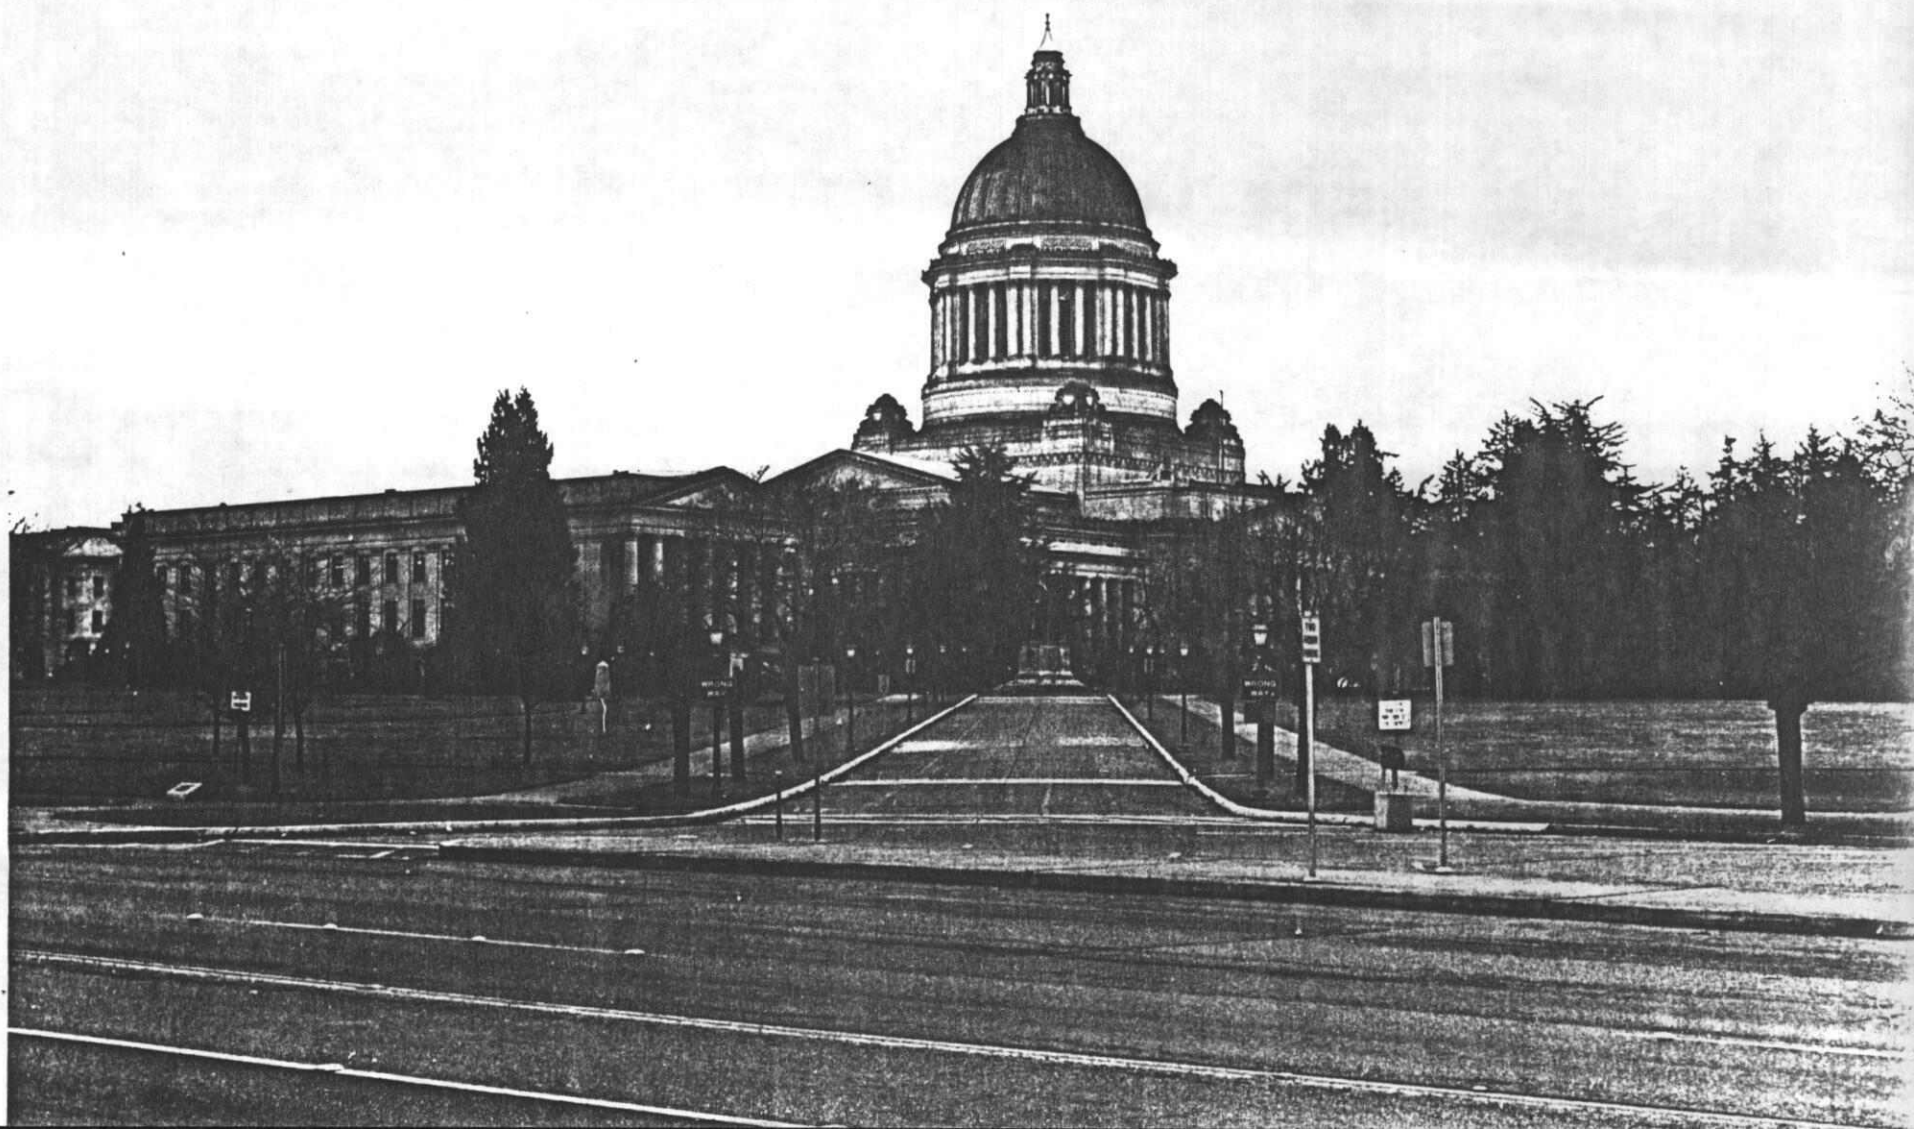
4 of 6

Washington State Capitol Historic
District: view of south end of
district looking west
Thurston County, Washington
J. H. Vandermeer
January 1979
Office of Archaeology and Historic
Preservation

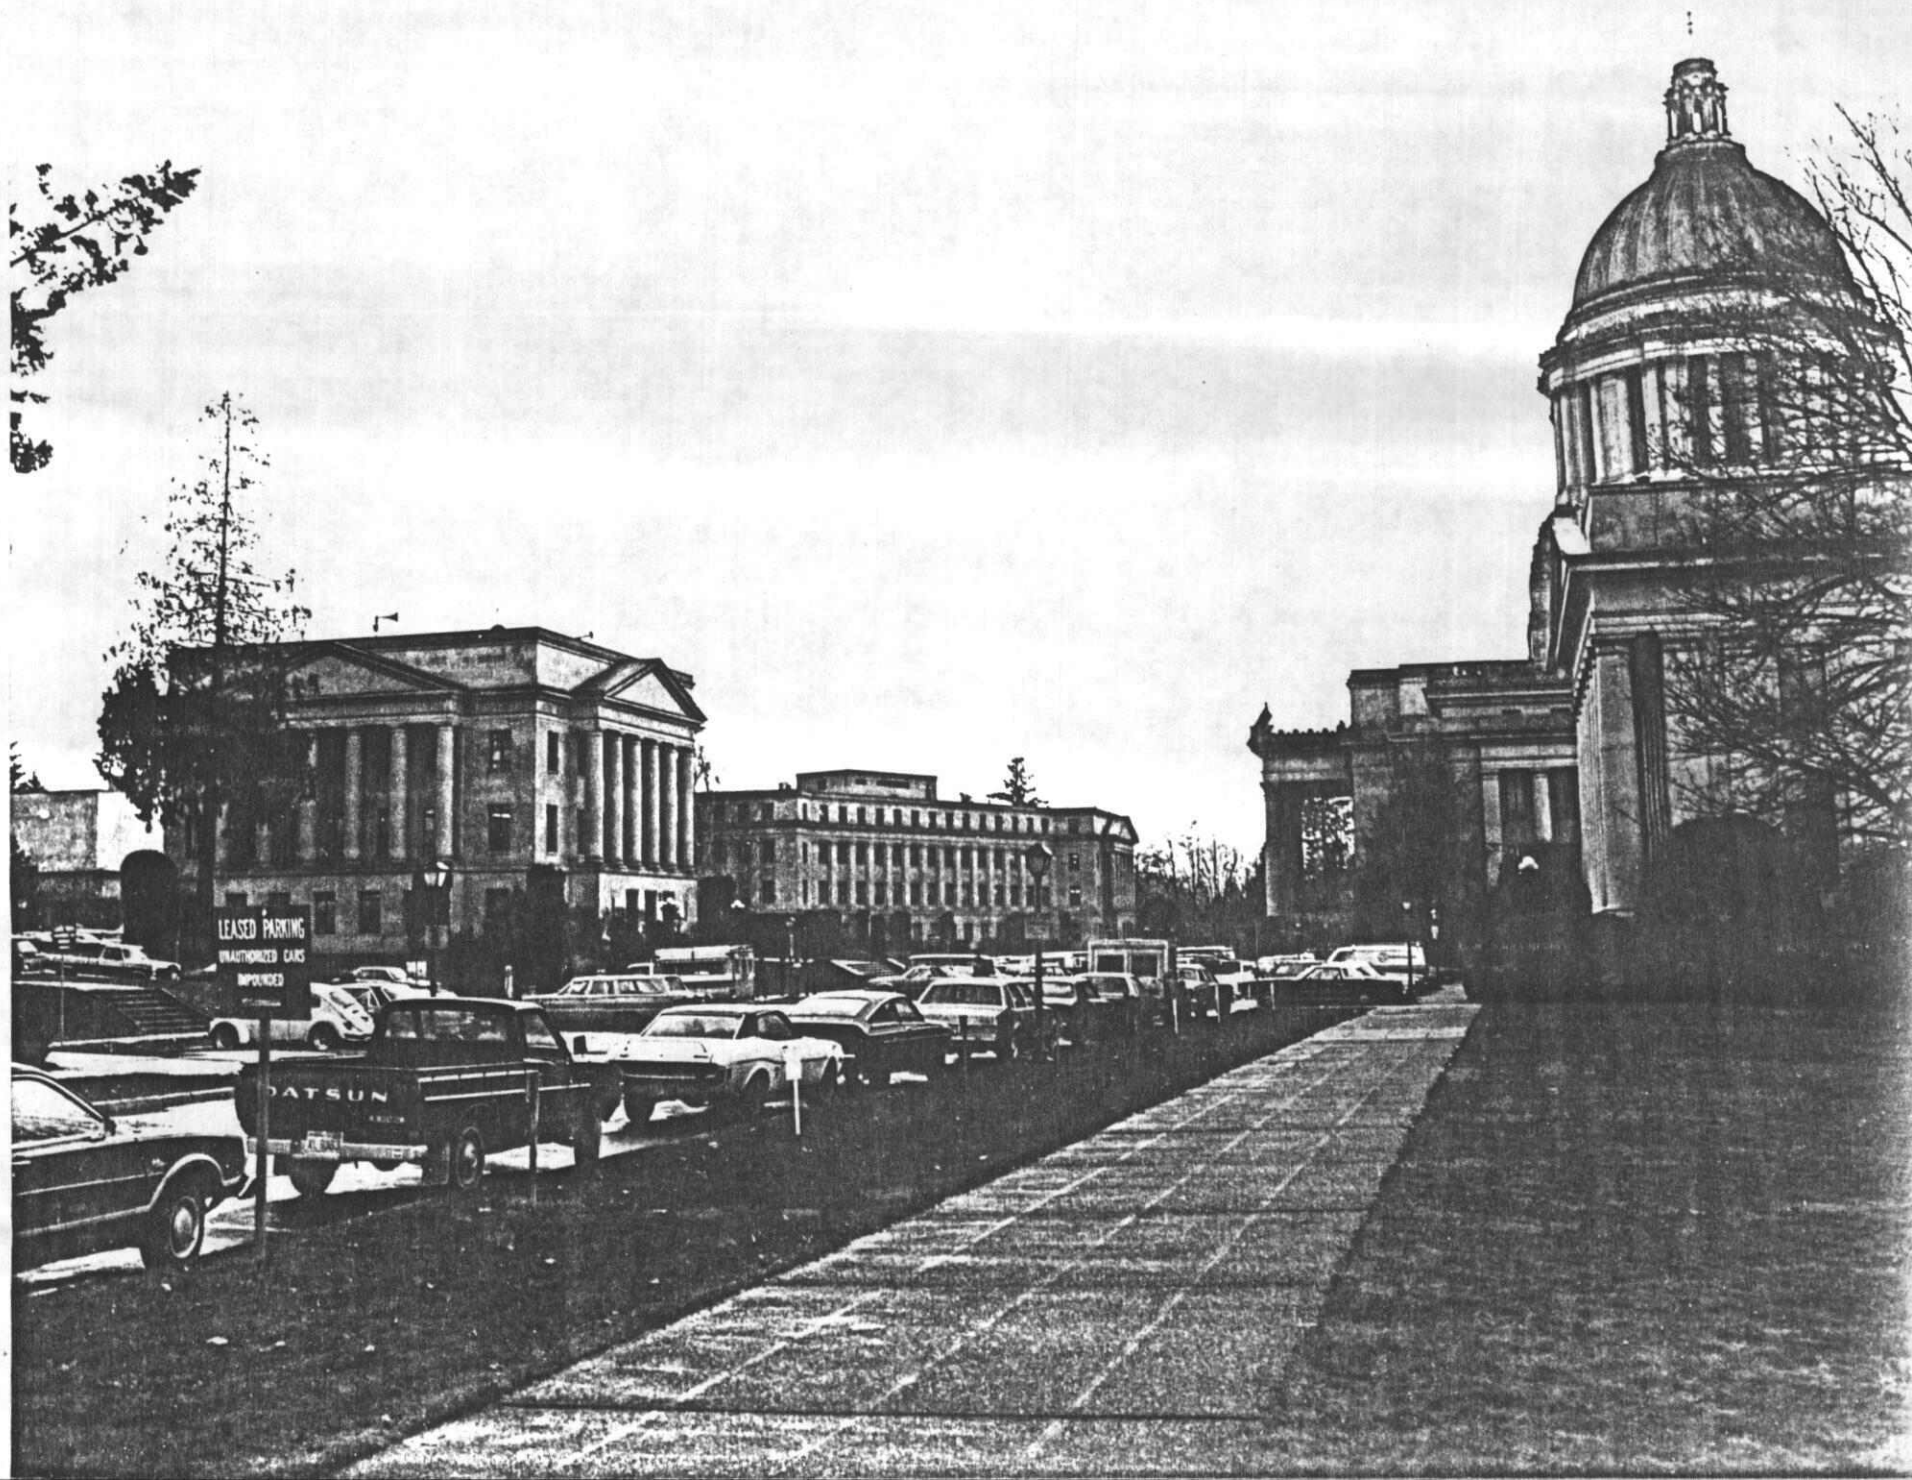
Washington State Capitol Historic
District: Temple of Justice
Thurston County, Washington
J. H. Vandermeer
January 1979
Office of Archaeology & Historic
Preservation, Olympia, WA
West and north facades

This building is located to the north of the Legislative Building, and between the two is a grassy courtyard and drive. The Temple of Justice is a long rectangle, with the longer axis running east/west. The south elevation is the front of the building and is remarkable for the grand colonnade along the entire facade. These are the same unfluted columns with Doric capitals that are used throughout the Group. A broad stairway leads to the central entrance on the south facade. Inside, a central hall, entirely of white and gray Alaskan marble, affords passage to the offices and public rooms of the building.

Of the latter, the most notable is the State Supreme Court, although the Law Library is also very handsome. These beautiful interior spaces feature high ceilings, rich woods, deep carpets and other appointments that lend that great dignity appropriate to the purpose of the rooms. Balancing what might otherwise be a ponderous mood is the fact that these spaces are flooded with natural light. Large casement windows with a southern exposure assure plenty of light on even the darkest winter days, and the huge Legislative Building across the plaza is a dominating presence, even from inside the Temple of Justice. The first of the Group to be built, the Temple of Justice was begun in 1912 and completed in 1920. The architects were Wilder and White.
